BRIDGE RE-EVALUATION SURVEY REPORT

**STRUCTURE NO. 0202-159
ROUTES US 1, 9 & 46 OVER JONES ROAD
BOROUGH OF FORT LEE
BERGEN COUNTY**

15TH CYCLE

JULY 15, 2008

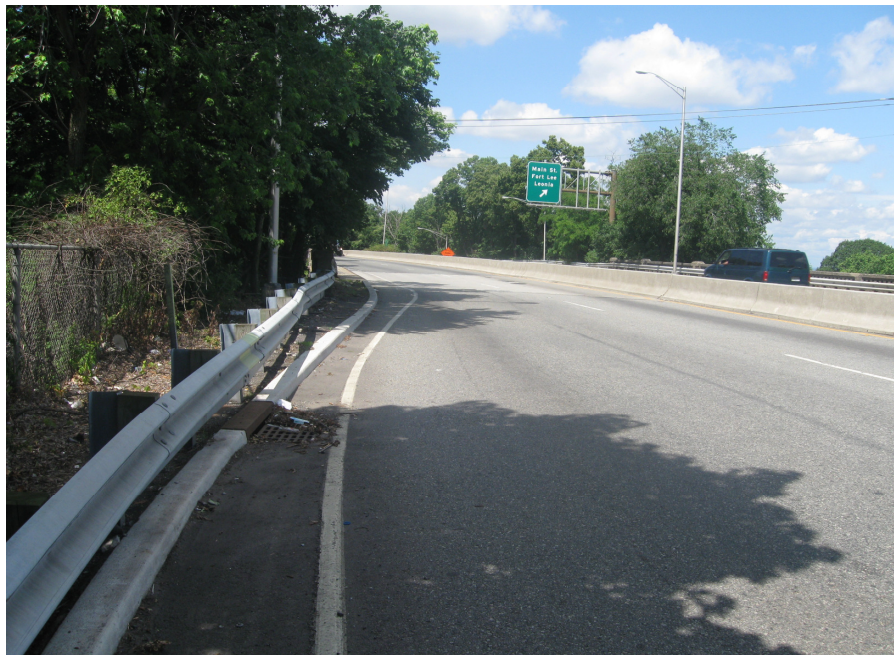
Photo No: 15-01

Location:	East elevation, looking West.
Description:	General view. Note: Structure fascia not posted for minimum vertical underclearance (typical west fascia).
